# CAUTION

These parts should be installed by a qualified worker. Hazardous voltages are involved. Make sure all current is shut off before starting. Never energize a circuit that involves a triac with any leads disconnected. Immediate damage will result.

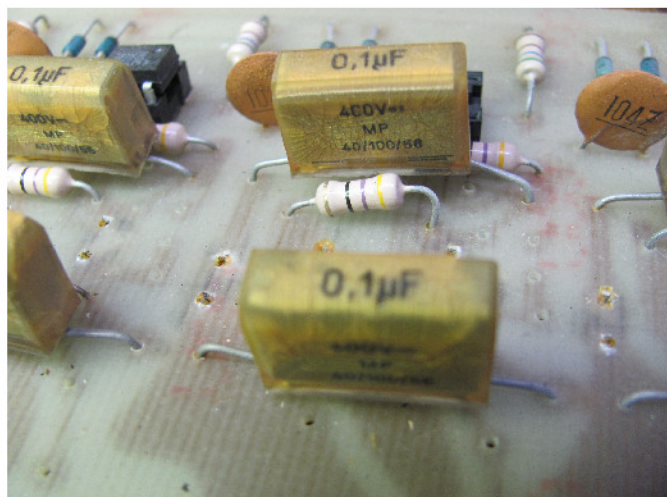
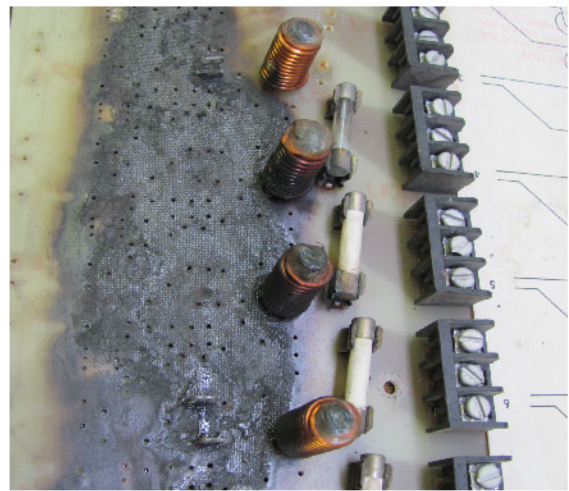
If your Litelab driver pack has a pull-out disconnect that sticks out of the front cover it may have two yellow capacitors on each channel that look exactly like this. These caps have a tendency to flare and should be replaced. Contact Audio Lite at 800-255-1015 for more information.

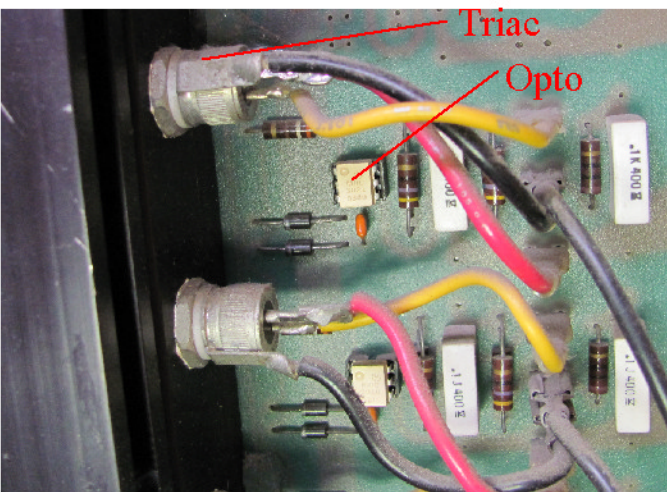
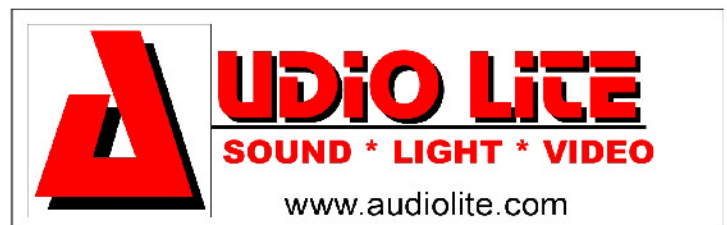
Litelab driver pack damaged by flared capacitors. Damaged parts have been removed. This board cannot be reused and cannot be replaced.
